**BULLETIN OF THE
SERVICE CITIZENS OF DELAWARE**

**GENERAL REPORT ON
SCHOOL BUILDINGS AND GROUNDS
OF DELAWARE**

OCTOBER 15, 1919

**GENERAL REPORT
ON SCHOOL BUILDINGS AND GROUNDS
OF DELAWARE
1919**

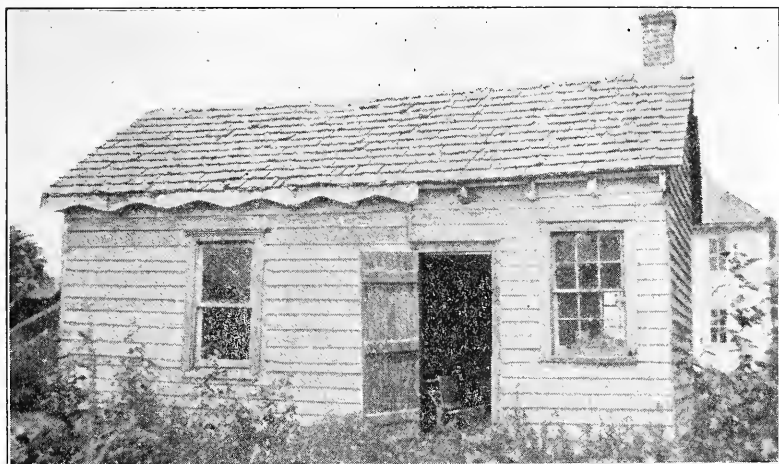
WHERE THE PRIMARY CHILDREN OF DAGSBORO ARE HOUSED

grove of trees has been planted and in a comparatively short time will add materially to the attractiveness of the entire situation. Except for minor defacement and a few broken window panes, hanging-down shutters, which can easily be remedied, the exterior of the building is in fair condition, but the interior, in construction

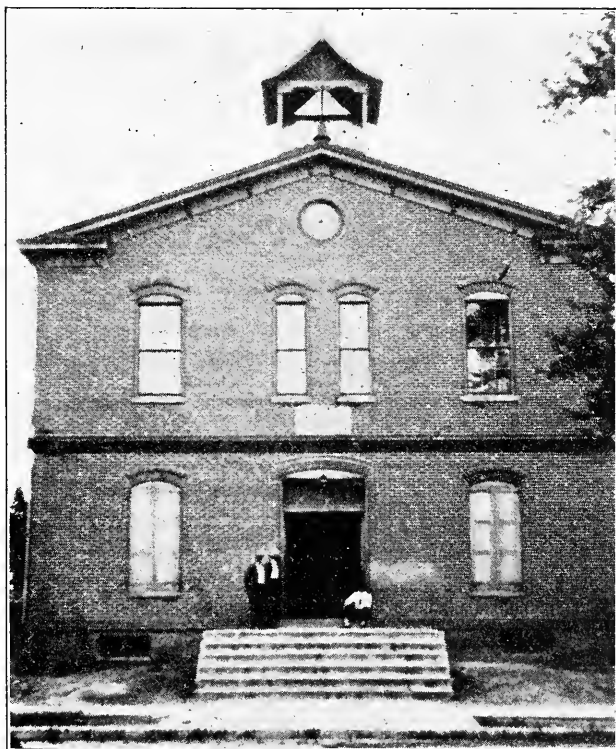
DELAWARE CITY SCHOOL

basement and are of the water flush type, but extremely inadequate in number and very insanitary in condition. The site upon which the building is located is very unsatisfactory both as to size and location. In the planning of a new school building for Delaware City an entirely new site should be selected. The building is heated by

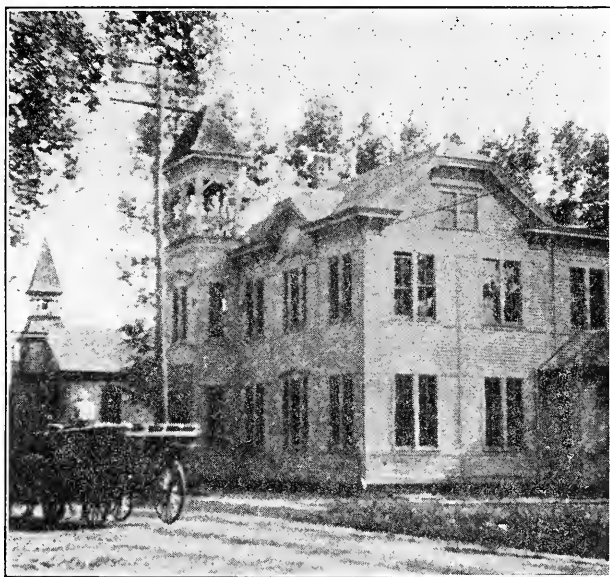
FELTON SCHOOL

deceptive. The very low score of 261 points is a measure of its effectiveness for school purposes rather than its appearance. The site is so small as to be entirely inadequate to the needs of so large a school, and the building proper, scoring only 49 points out of a possible 165, is sufficient in itself to condemn the plant. The measure of the building in meeting the problems of the health and comfort of the children is indicated by the score of 40 out of 280 for service systems. The lighting of the class rooms is bad throughout. One

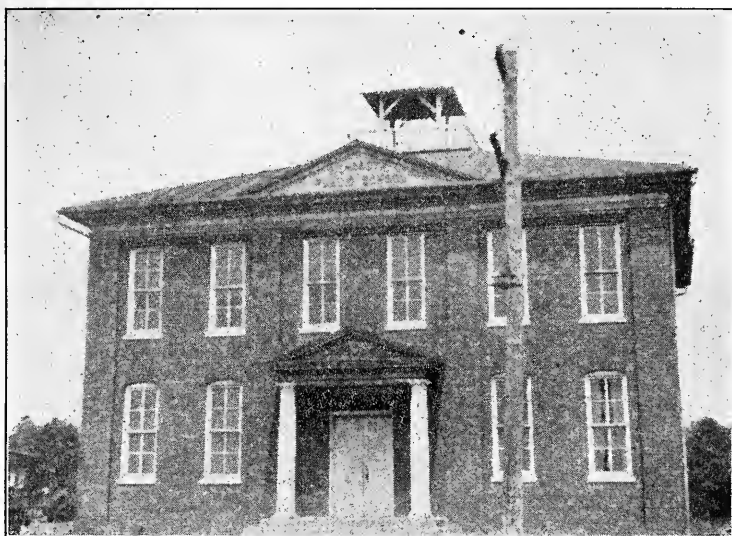
REHOBOTH SCHOOL

This building is a six-room, two-story brick structure, built in 1908. It is in good condition externally, but is a cheap type of construction, with tin roof and unfinished basement. In planning the interior of the building no consideration has been given to the standards of modern school architecture. The class rooms are irregular in shape, poorly arranged and lighted from two sides. The stairway and corridor arrangement is extremely bad and entails considerable fire risk. The opening through which the occupants of the three upper story rooms would have to pass in case of fire is but 41 inches

which case nothing short of a complete renovation of the building, excavation and improvement of the basement, additions of special room and the installation of fire escapes will make the building acceptable.

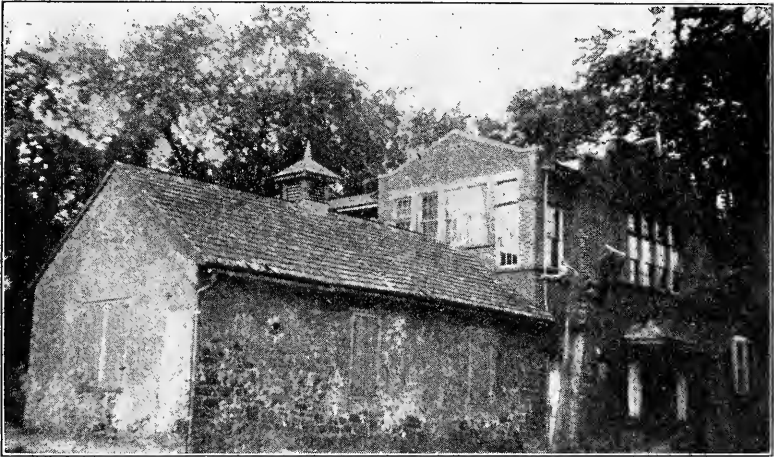
RICHARDSON PARK, DISTRICT NO. 20

that will be required to attend. The lighting is not good, coming as it does from both left and rear of the pupils. The windows might easily have been banked on one side and standard lighting conditions met. One especially commendable feature of the building is found in the fact that the partitions between each adjoining pair of class rooms are so arranged as to be lifted, thus throwing the two rooms into one. This makes it possible for the building to render valuable service as a community center and to increase its usefulness in the district.

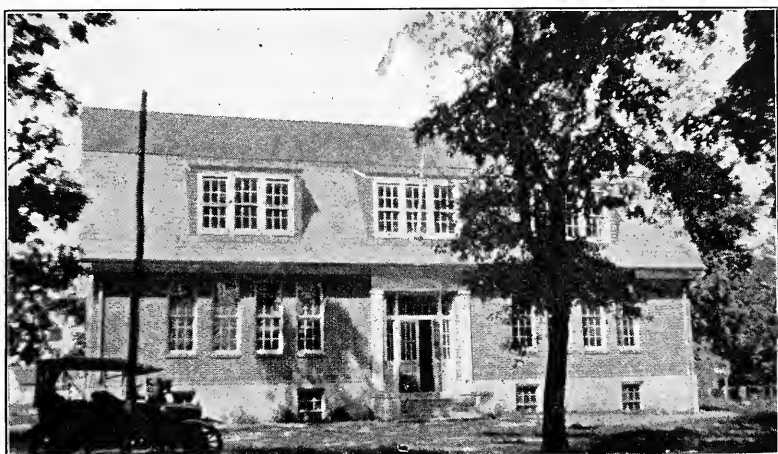
TOWNSEND SCHOOL

The commission regrets to announce to the well-intentioned citizens of Townsend that their new building scores but 536 points out of 1000. While this is one of the highest scores recorded in the county, it might have been 300 to 400 points higher with comparatively little additional cost.

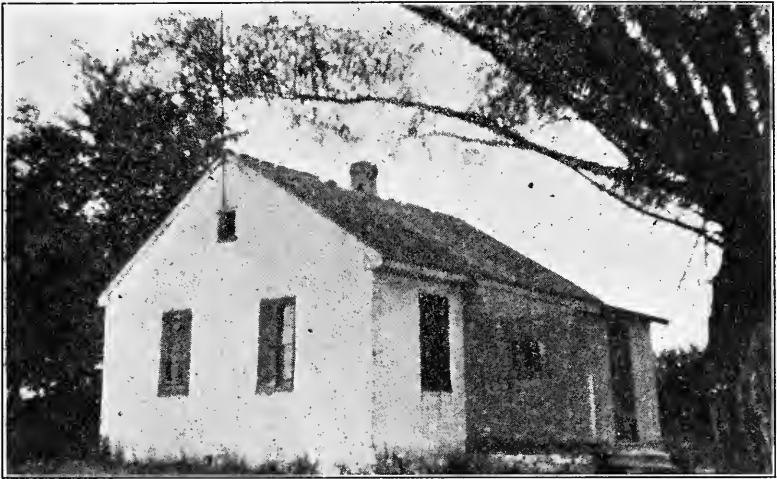
OGLETON SCHOOL

Ogleton is another of the old, very old, stone blockhouses. It is also located on one of the proverbial triangular sites in the fork of the roads. It possesses no single attribute which justifies its use for housing children. It is dark and depressing on the inside and unsightly from the outside. The toilets are in a very insanitary condition, vilely defaced and located within ten feet of the class room windows, which are the only source of ventilation. It is a crime

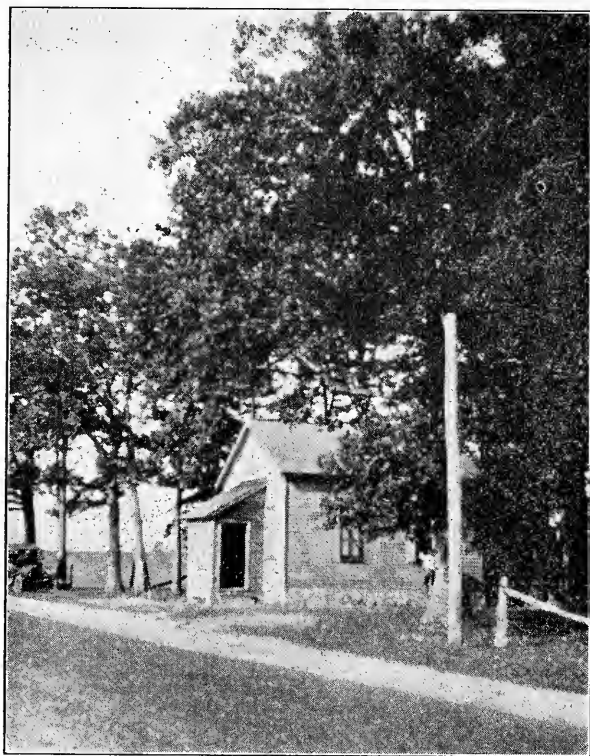
FIELDSBORO SCHOOL

points the building has. The building proper scores but 45 points in 200. The service systems are even lower in score than the very low score set by other buildings of the same general type. The class

room has nothing to recommend its further use. It is lighted from four sides. The blackboards are so poor as to score but 2 points out of 15 and the seats and desks but 2 in 30. The building should be closed and the children transported to a better building.

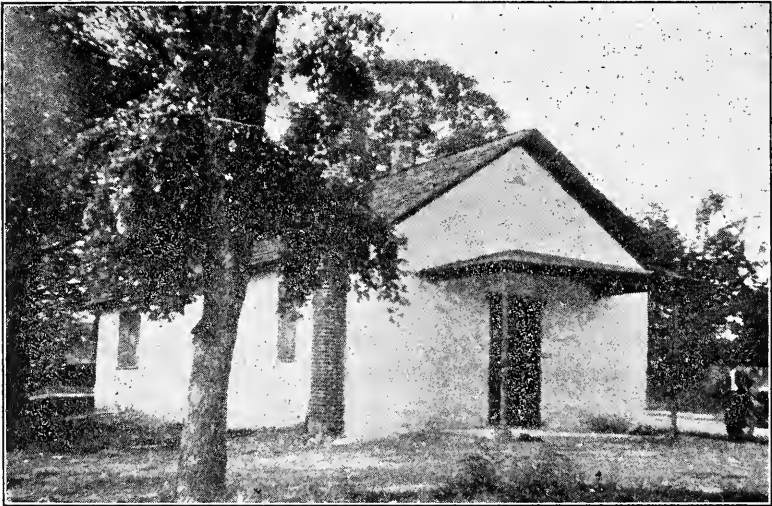
SHELLPOT NO. 73

benches can be rated as seatings, are provided for 45 children in a room 18x27. In order to get this number of seats in it has been necessary to place the seats squarely against the walls on both sides of the room. This arrangement precludes the possibility of side aisles or the use of the side walls for blackboard space. The accompanying picture shows the lighting conditions which the children so seated are compelled to suffer. The survey commission wishes to place special emphasis upon the recommendation that this building be closed.

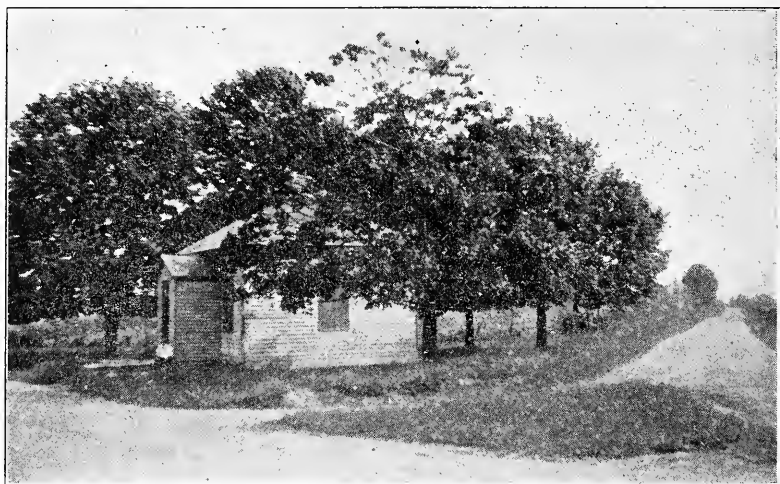
MILL LANE SCHOOL

The Mill Lane building is 18 feet square, seating 16 pupils, and located on a little triangular plot of land in the fork of the road. It does not fly the American flag. It is heated by a stove in the center

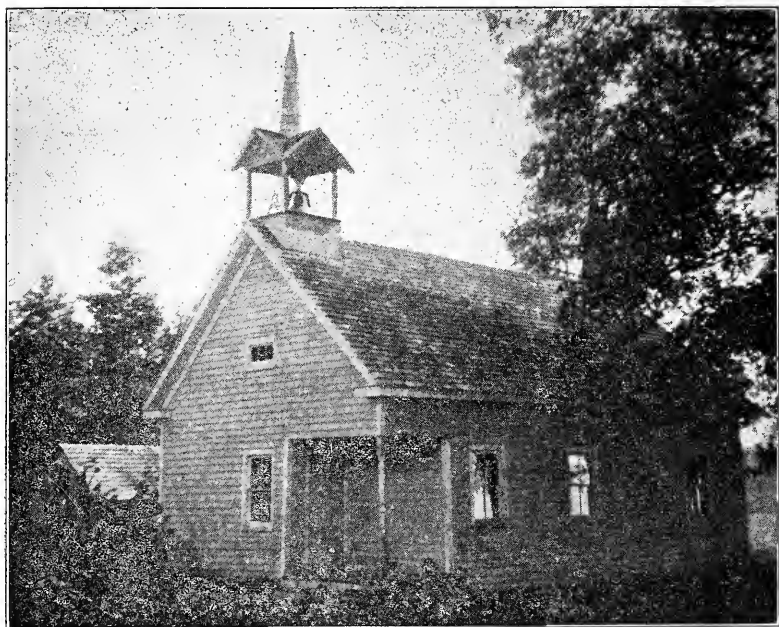
SANDTOWN SCHOOL

The Sandtown School is a one-room, frame structure, 18x28 feet, in fairly good condition, located on a site almost surrounded by dense woods. The location of the building on a shell road adds much to its accessibility, but the nature of its surroundings makes the extension of the present site undesirable. The building itself cannot be altered to provide amply for a modern educational program, and at the earliest possible date should be turned to some other

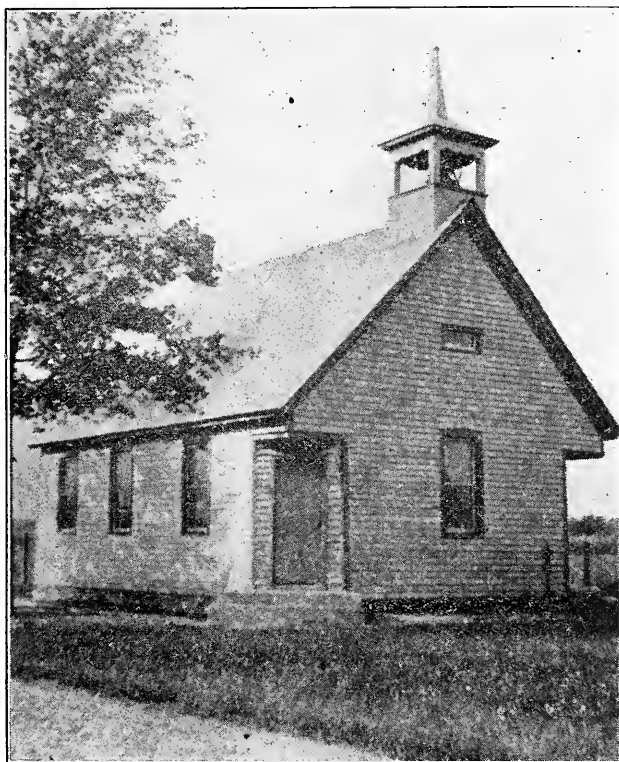
PETERSBURG SCHOOL

The Petersburg School is a comparatively new frame building with a well arranged vestibule, double entrance and concrete steps and walk. The building is in excellent repair, well painted, and the grounds are made as attractive as their size and form will permit. The site is, however, most unfortunately chosen, being, as it is, a

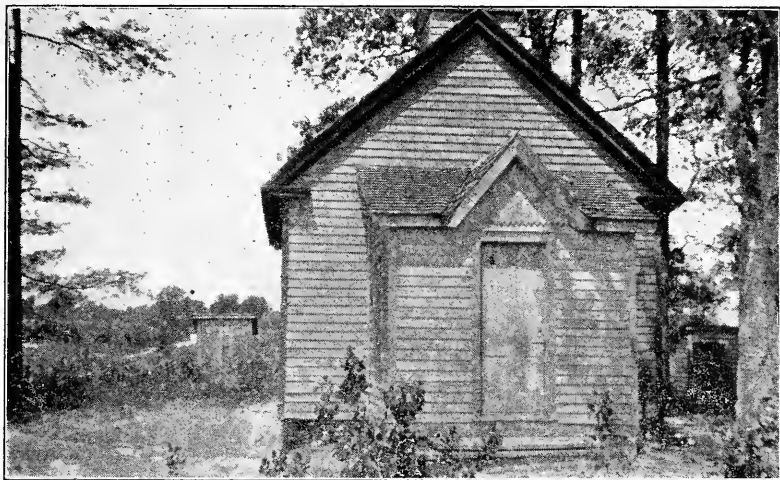
CEDAR GROVE SCHOOL

The site selected for this school is even more undesirable than the common run of undesirable sites in the county. It has about every undesirable feature possible. It is surrounded on two sides by low, swampy ground, is triangular in shape, and standing, as it does, on a little knoll, it has been washed so that there is no part of the surface that is not covered with deep gullies. It is obvious,

therefore, that there is no space anywhere except upon the road which passes by, in which children can play. The building is extremely old and in very bad condition. Little financial loss will be entailed in the complete abandonment of the entire plant. It will be noted from the detailed score on this building that it ranks among the lowest in the entire county. One of the toilets at this school, which apparently has not been cleaned out in years and which in consequence is extremely foul smelling, stands within fifteen feet of the windows of the classroom. This, together with the fact that the only provision for ventilation is through the windows of the building makes it a matter of very grave concern to the comfort and health of the children housed within.

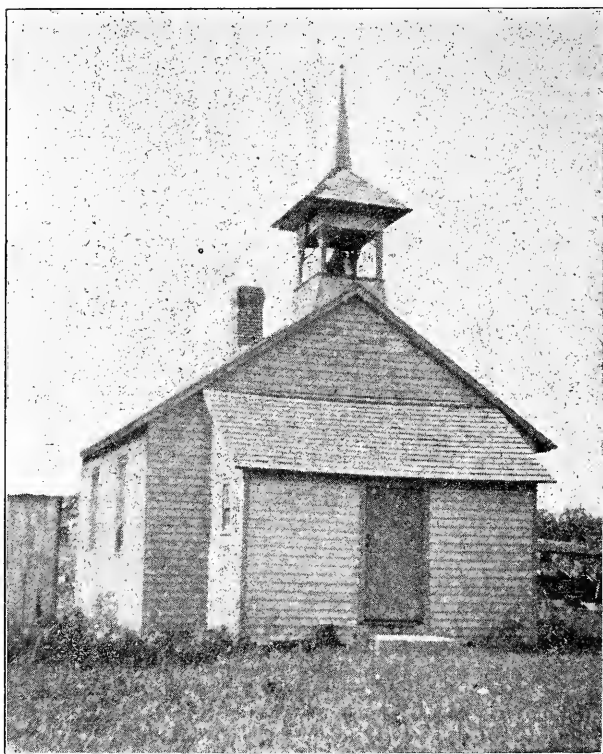
WESTVILLE NO. 69

regarded as adequate school needs. The very size, however, of the building condemns it as a school building, and as such it should be abandoned at once. The light area of the class room is low and poorly placed, there being but four windows, two on either side of the room.

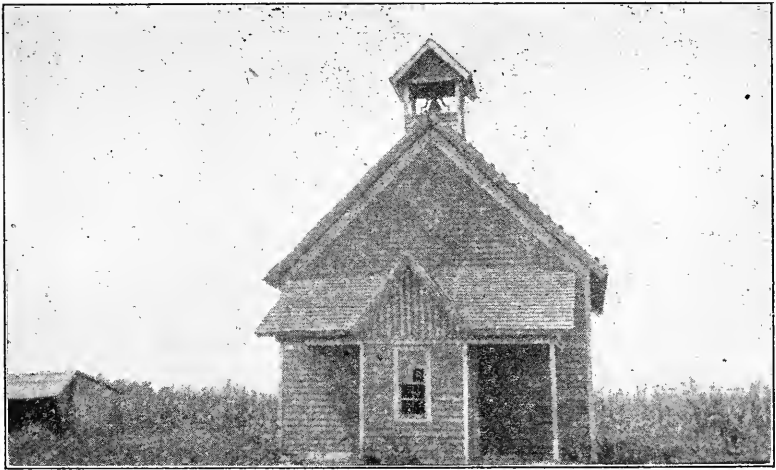
HOLLANDSVILLE NO. 87

as to justify the urgent recommendation that the citizens of this community take immediate steps to provide an adequate school plant for the education of their children. No single feature of the building approaches a satisfactory standard.

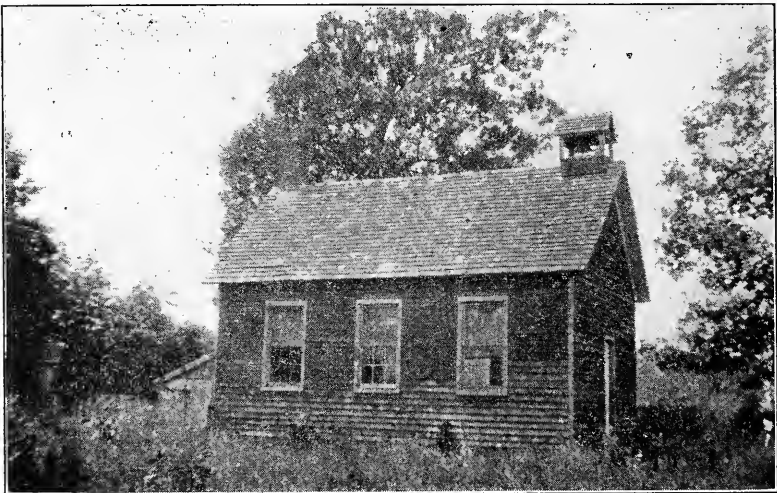
POTASH NO. 100

every detail except that a modern heater has been installed. It is located in a dense woods and all of the little tract of land which at one time was cleared for the school building has grown up in dense briar and small underbrush. Aside from exciting the type of oratory above mentioned the schoolhouse of this type does not serve adequately any of the purposes for which modern school buildings are erected. It should be abandoned at once and the children transported to more suitable quarters.

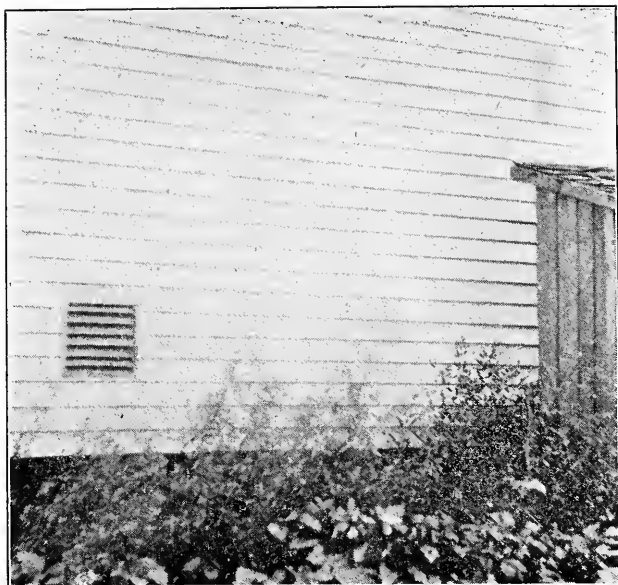
TRINITY NO. 73½

class room is comparatively good and the blackboard space and equipment is better than the average found in the county. The glass area is low and the windows are distributed on two opposite sides of the room. One feature of this building is especially bad and should be corrected immediately, namely, the location of the toilets with respect to the air intake of the jacketed heater. The toilets, which are of the double compartment community type, are located $2\frac{1}{2}$ feet from the rear of the building and six feet from the air intake. This condition undoubtedly supplies the class room with foul-smelling, impure air. It is inconceivable that intelligent workmen would locate the toilets or the air intake in such positions. This district could easily and practically consolidate with the adjoining districts.

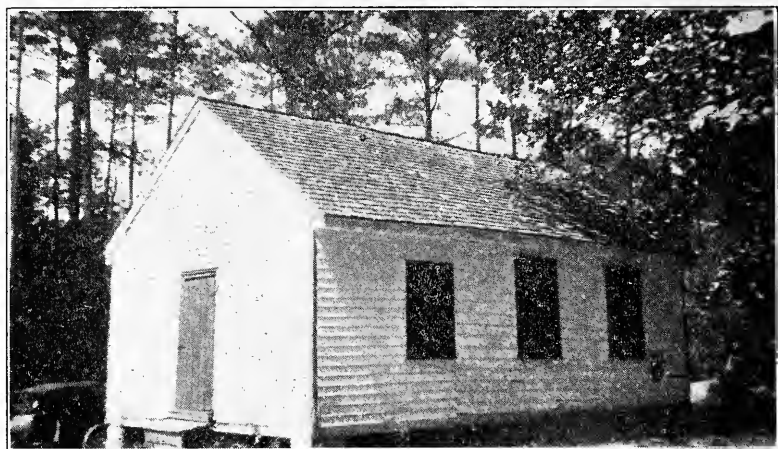
MCNEAL'S SCHOOL

The McNeal's school, locally and more appropriately known as "Hog Yard," is a one-room, frame building, approximately 16x22 ft. in dimensions, located in a small irregular, triangular clearing in an oak woods. Except for the narrow unimproved roadway running by the building the site is surrounded on all four sides by dense woods. The building is very old and in a very bad state of repair. The roof is moss grown and the open brick foundation offers little support to the building and no protection against cold winter storms to the floor of the class room. The site is too small and impossible

of extension or improvement to meet standard requirements. The interior of the building, except for the improved heater is of the type one might have expected to find in the pioneer schoolhouse. It is dark, dirty and untenable for human beings, unless, as is the case with school children, they are compelled by law to attend. The meager equipment is of the poorest type and much abused. Old double seats badly carved and mutilated are extremely unsatisfactory, and the teacher's desk is of the same general character. The glass area is low, and the windows are placed on three sides of the room. There is no justifiable excuse for the use of this building for school purposes, and in the light of modern civilization it should be condemned and closed. The pupils should either be provided with a modern one-teacher school or transported to a graded school at some point agreed upon with neighboring consolidating districts.

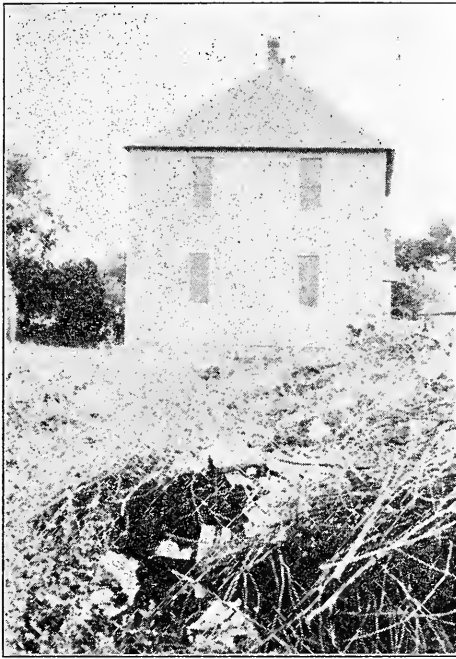
Colored school at Milford, Delaware. One of the best of the frame buildings provided for colored children in the special school districts. It is unfortunate that the dumpheap is in such close proximity to this school. The outhouses for this building were in the usual insanitary condition. The site is small and no conveniences provided for teachers or pupils. This four-room school will not provide the type of education that children of a democracy ought to be getting.
